access to the environment

Case Studies of Barrier Free Sites

Volume 2

**A Series of Reference Documents on the Design and
Development of Site Facilities to Make Them
Barrier Free to the Physically Handicapped and Disabled**

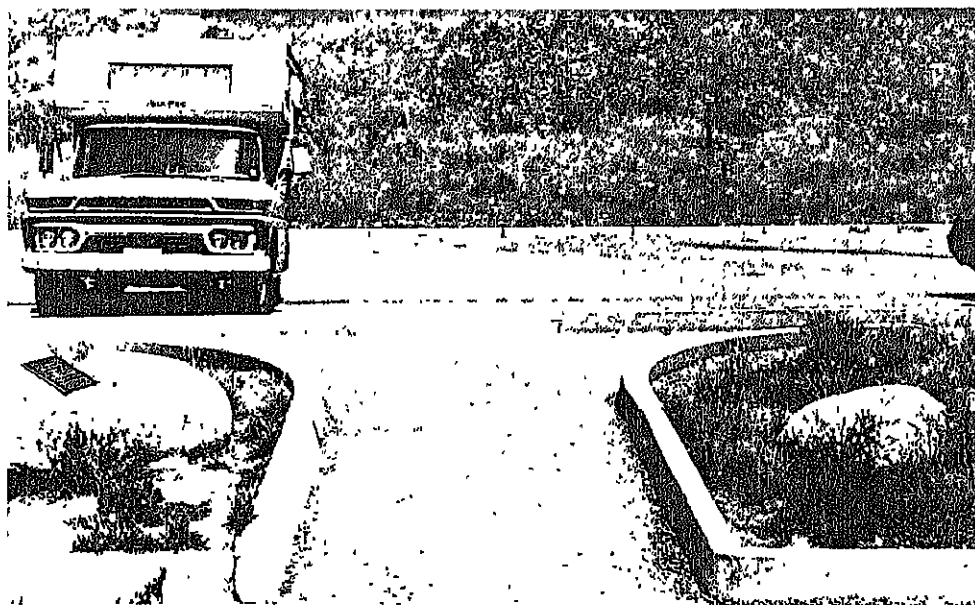
As the visitor reaches the top of the slope, he can easily make his way to the parking lot via an asphalt path between two curbed planting areas. Wide cuts through the wheel stop curb provide easy access to the car for the wheelchair user.
